MILL WATER DAM

BERKS COUNTY, PENNSYLVANIA

(NDS I.D. NO. PA 00703,  
DER I.D. NO. 6-442)

PHASE I INSPECTION REPORT  
NATIONAL DAM INSPECTION PROGRAM

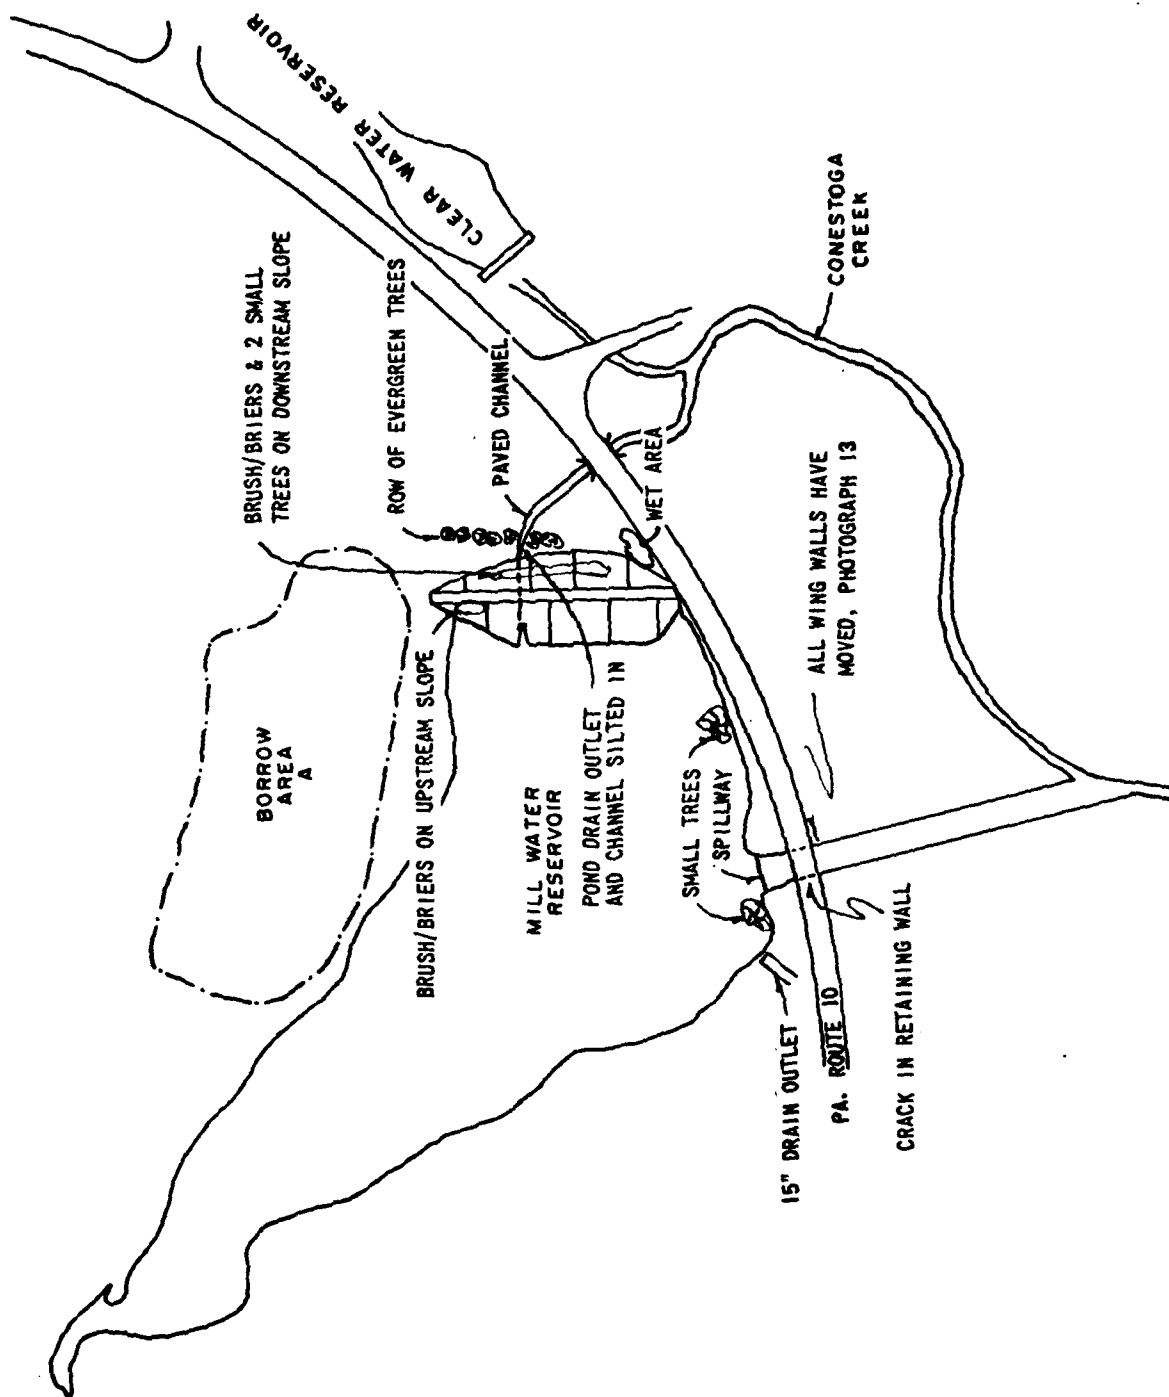
FIELD OBSERVATION PLAN  
MILL WATER DAM  
SHEET 5A OF 11

b. Dam. During the visual inspection, there were no indications of distortions in alignment or grade that would be indicative of movement of the dam or the foundation. The vertical alignment of the dam was checked and spot elevations are shown on Plate 2, Appendix E. As shown in Photograph 9, heavy brush and briars are growing along the waterline of the embankment. Sumac is also growing along the waterline on the side of the reservoir next to the road, but is not considered detrimental as this is natural ground. The crest is protected with grass which is mowed, and the downstream slope is brush covered. There are two small trees starting to grow on the downstream slope. At the toe of the slope some evergreen trees are growing. The only seepage noted was at the junction of the dam embankment and the highway embankment, as shown on sheet 5a, Appendix A.

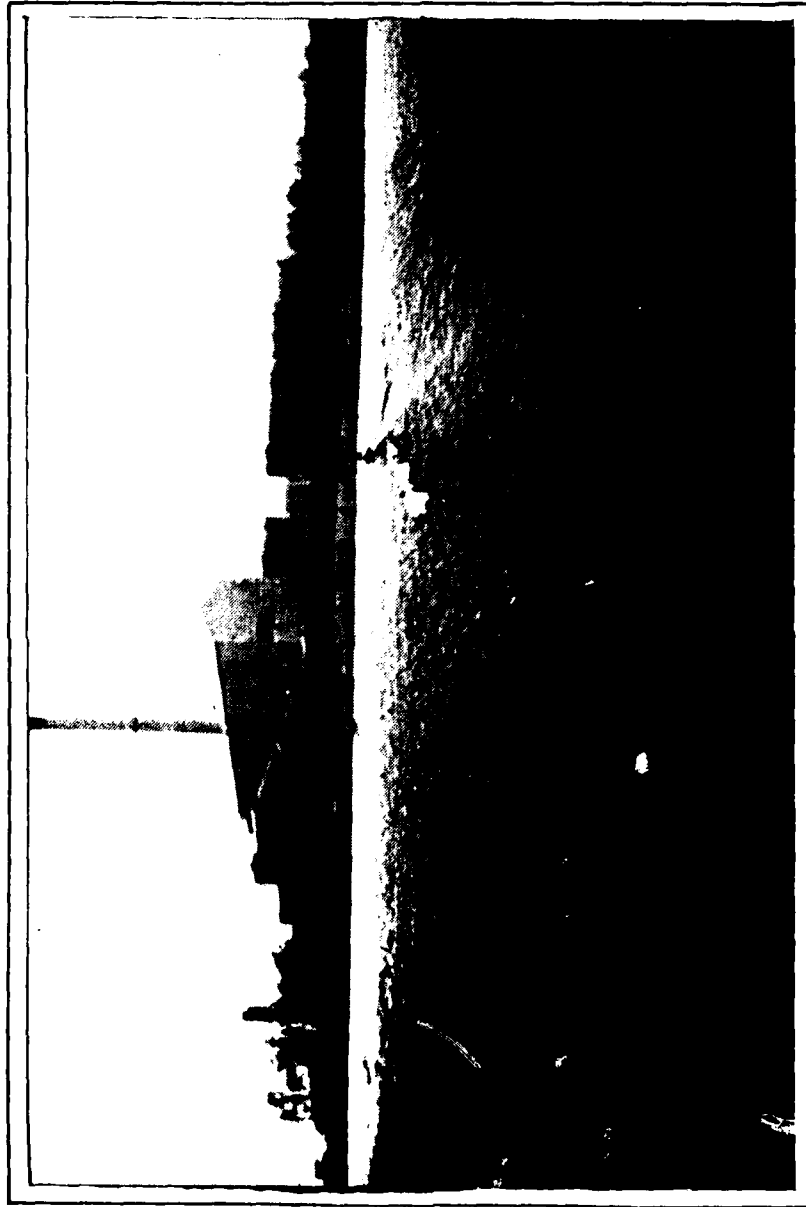
PHOTOGRAPH NO. 10

1. Spillway. The concrete ogee weir appears to be in good condition with some cracking. Photograph 10 shows a surface irregularity of the crest of the weir. The same irregularity shows up in a photograph included in DER files. There are leachate deposits in horizontal cracks in the weir, indicating seepage through the weir. Some erosion of the concrete has taken place where the bottom of the weir meets the channel pavement. No significant deterioration or movement of the pavement or the channel sidewalls was noted. The PA Route 10 bridge crossing the spillway chute was also inspected. As shown on Photograph 13, rotation and separation has occurred at each wing wall and bridge junction. Photograph 12 shows a crack extending the full height of the right retaining wall under the bridge. The crack is wider at the top.

OGEE CREST, CONCRETE SURFACE HAS  
BUCKLED AT LOCATION OF THE WHITE  
WATER.

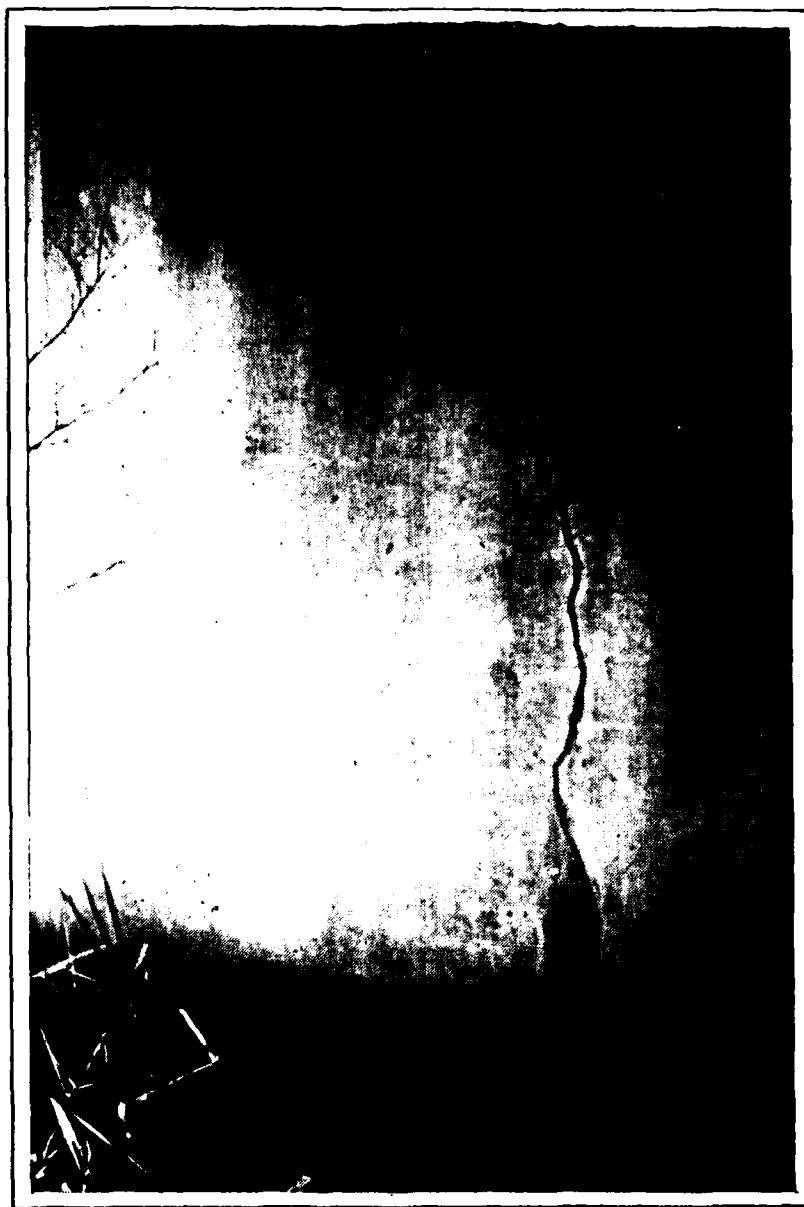
PHOTOGRAPH NO. 12

VISUAL EXAMINATION OF	OBSERVATIONS	REMARKS OR RECOMMENDATIONS
CONCRETE WEIR	<i>The concrete ogee weir appears in good condition with some cracking. Leachate deposits at horizontal cracks in weir indicate seepage through weir. Some erosion of the concrete has taken place where the bottom of the weir meets the channel pavement.</i>	
APPROACH CHANNEL	<i>None.</i>	
DISCHARGE CHANNEL	<i>There has been some settlement of chute wall backfill at construction joints.</i>	
BRIDGE AND PIERS	<i>The right bridge abutments show up to three inches of movement and a crack, estimated to be an inch wide at the top, extends from the top to the bottom of the wall near the downstream end. See Photograph No. 12.</i>

CRACK IN RIGHT BRIDGE ABUTMENT.  
THE CRACK IS ABOUT ONE INCH WIDE  
AND SIX INCHES DEEP AT THE TOP.

3. The highway bridge over the spillway channel should be inspected by a PennDOT engineer to assess the need for repairs.
